**The Report  
Of a Project to Identify, Survey and Record  
Archaeological Remains at Rogie, Ross-shire  
February 2008 – May 2009**

**The Report of a Project to Identify, Survey and Record  
Archaeological remains at Rogie, Ross-shire  
carried out by the North of Scotland Archaeological Society,**

**February 2008 – May 2009**

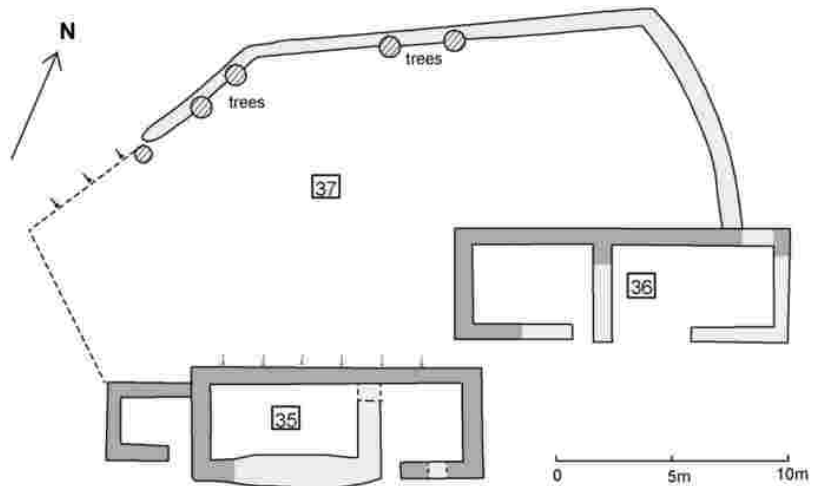
**Upper Rogie - North East settlement**  
(schematic plan only)

**GR NH 4416 6007 sites 35 - 37**

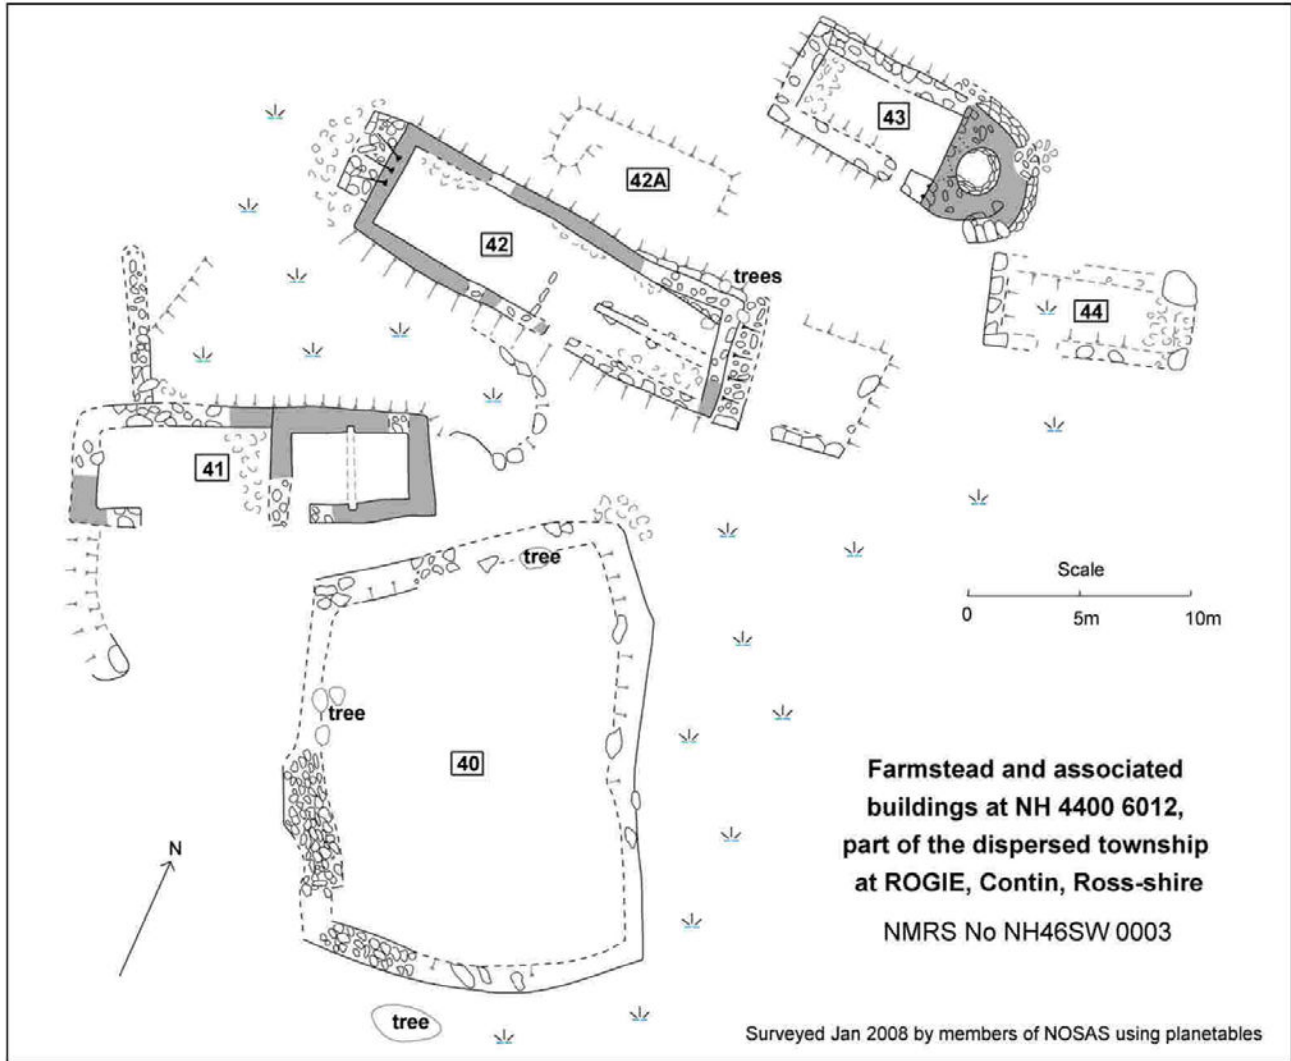
**43 Kiln and barn (figure 3)** - NH 44009 60135 Aligned E-W this structure has an overall measurement of 7m x 3m. The kiln is well preserved and of dry stone construction, it is generally 1.6m high. The bowl has a diameter of 1.8m and it is 0.5-1m deep although there is some tumbled material inside. Unusually there are two flues in the straight west face which is 1.1m in height. The south one appears blocked although it can be probed to a depth of 0.9m, it has an aperture of

1m width x 0.3m height externally, narrowing to 0.3m width x 0.1m height. The north flue is 0.5m wide, 0.2-0.4m depth and 1m in length.

Externally there is an abutting feature on the SE side of the structure, this takes the form of a rising ramp of large stones, this may have been steps up to the top of the kiln.

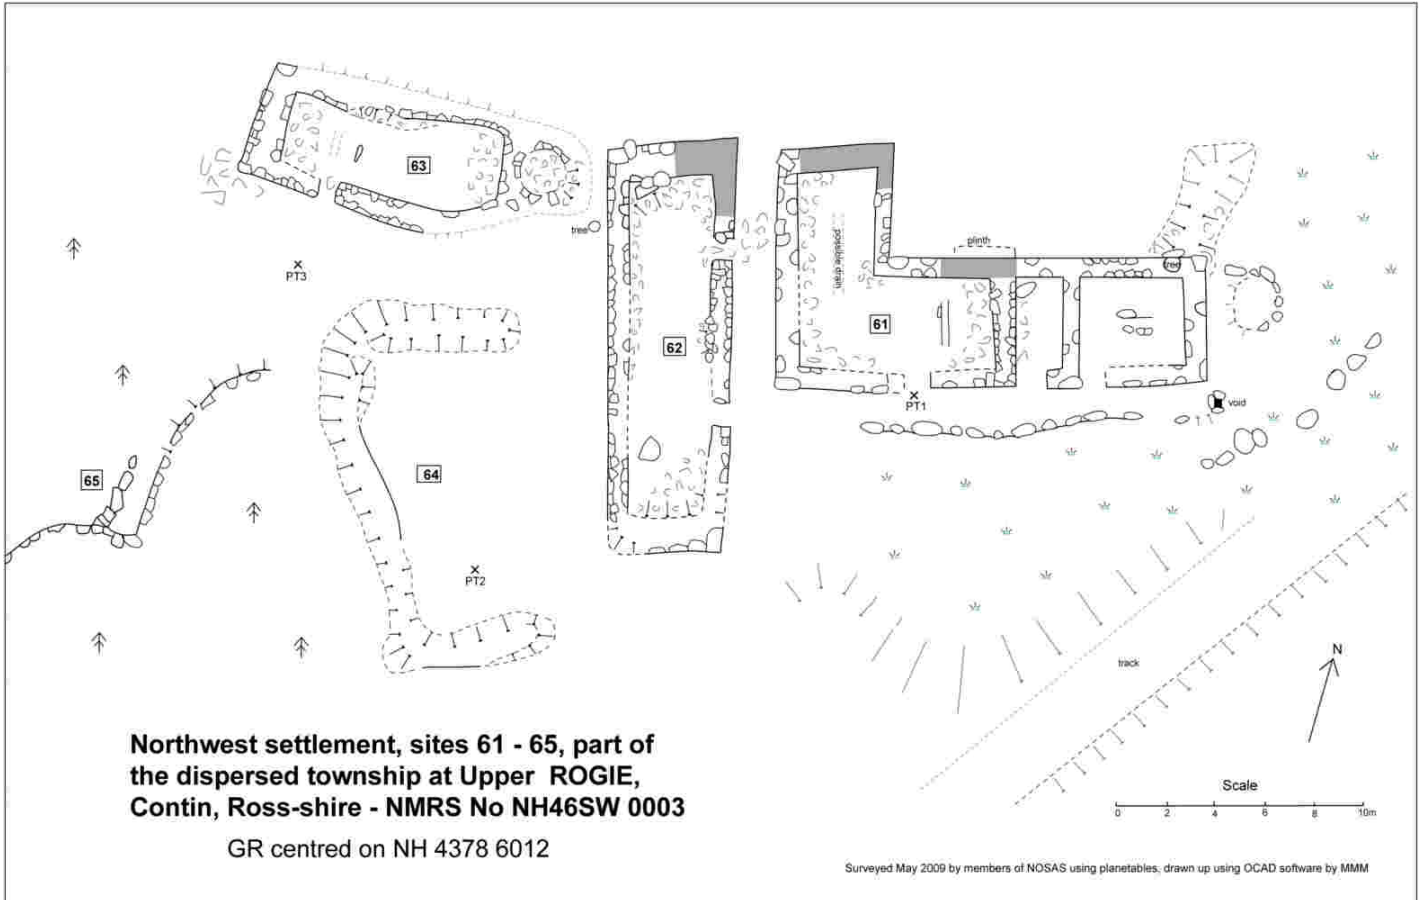
**61 Building/?Byre** (figure 4) - NH 43796 60120 A reversed L-shaped building, on a ENE-WSW alignment, comprising 3 compartments.

- The main, largest compartment, to the west, measures 7.8m x 3.8m internally, with the extension to the NW of an additional 4.4m x 3m. The dry stone walls in the south and west part are 0.2-0.3m high whilst those to the north are 0.6m high externally and that at the north end of the extension is 1.2m. A few features were noted - 1. An entrance in the SE wall possibly 1m in width, although the surviving aperture suggested 1.8m in width. 2. A stone edged drain in the E part of the compartment is 0.3m wide x 2m length x 0.2m deep. A possible further one is seen in the west part,

To the SE of the building a terrace runs along the length of the building. It is 2m width in the west part and 1.2m in the east part. It is bounded by large boulders with a drop 0.3-0.5m to a marshy depression which appears to be man-made. The marshy depression is 8m N-S x 16m SW-NE narrowing at the NE end. It has steep banks to the south and east.

At the SE corner of the building a stone lined void, 0.2 x 0.2m x 0.8m depth may be the socket for a timber post. At the NE corner, the wasted turf and stone wall of enclosure 54 abuts.

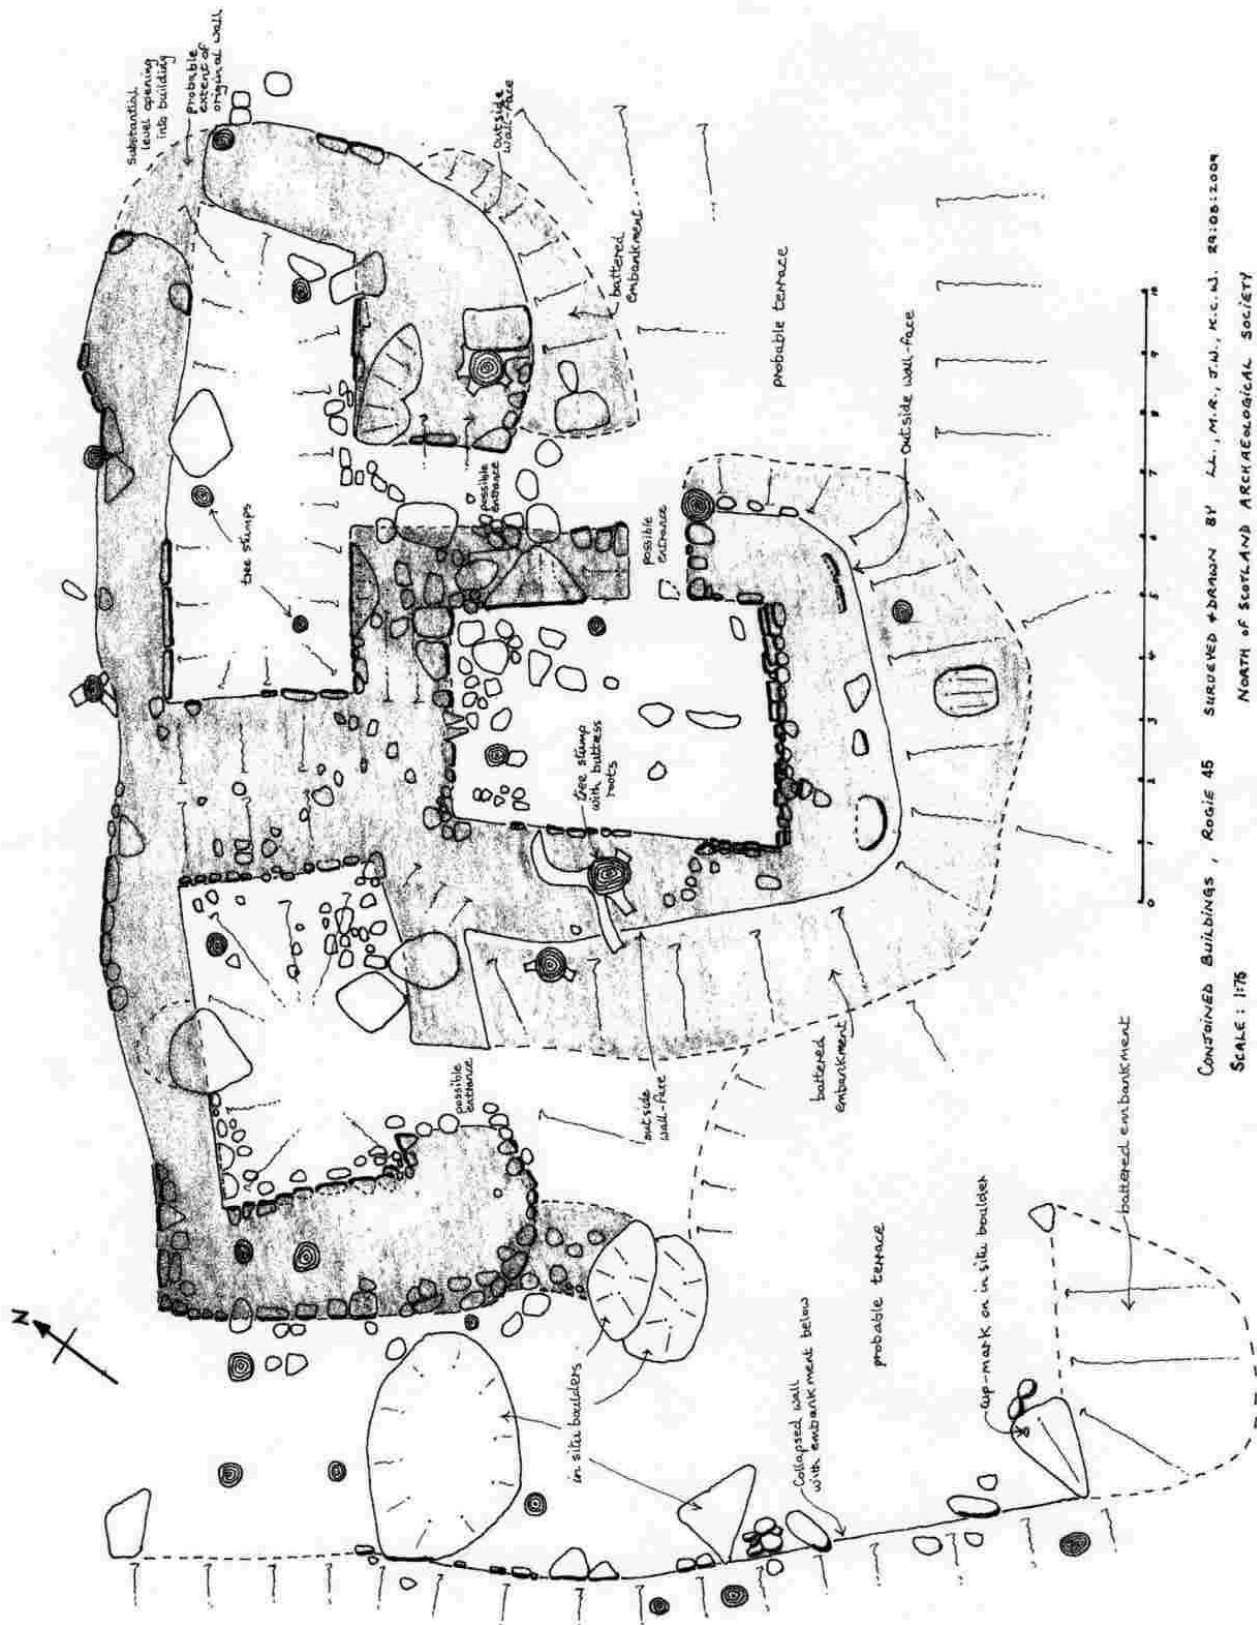
CONTAINED BUILDINGS, ROSSIE 45 SURVEYED DRAWN BY A.L., M.R., J.W., K.C.N. 29:08:2008  
 SCALE: 1:75  
 NORTH OF SCOTLAND ARCHAEOLOGICAL SOCIETY

The building measures 20m x 14m overall. The main axis is NE-SW and there are 2 compartments to this part of the building, but there is also a third compartment on the east side, see drawing. All the walls of the building have been solidly constructed of earth, rubble and large boulders. Their remains are generally 0.5m to 0.8m high and between 1.5m and 2m thick and even 3m in some places.

The west compartment measures 5m x 3.5m internally and there is an entrance 1.3m wide in the SE wall. The NE compartment measures 7.5m x 3m internally, again there is an entrance in the centre of the SE wall. There may also be an entrance into the east compartment at the west end of this SE wall, but an opening at the NE corner has probably been made by forest vehicles gaining entry. The SE compartment is aligned at right angles to the other two and is 4.5m x 3.8m internally. It has an entrance in the NE wall. The building sits on a revetted platform 25m x 15m, the SW side of which has been built up considerably with large boulders.

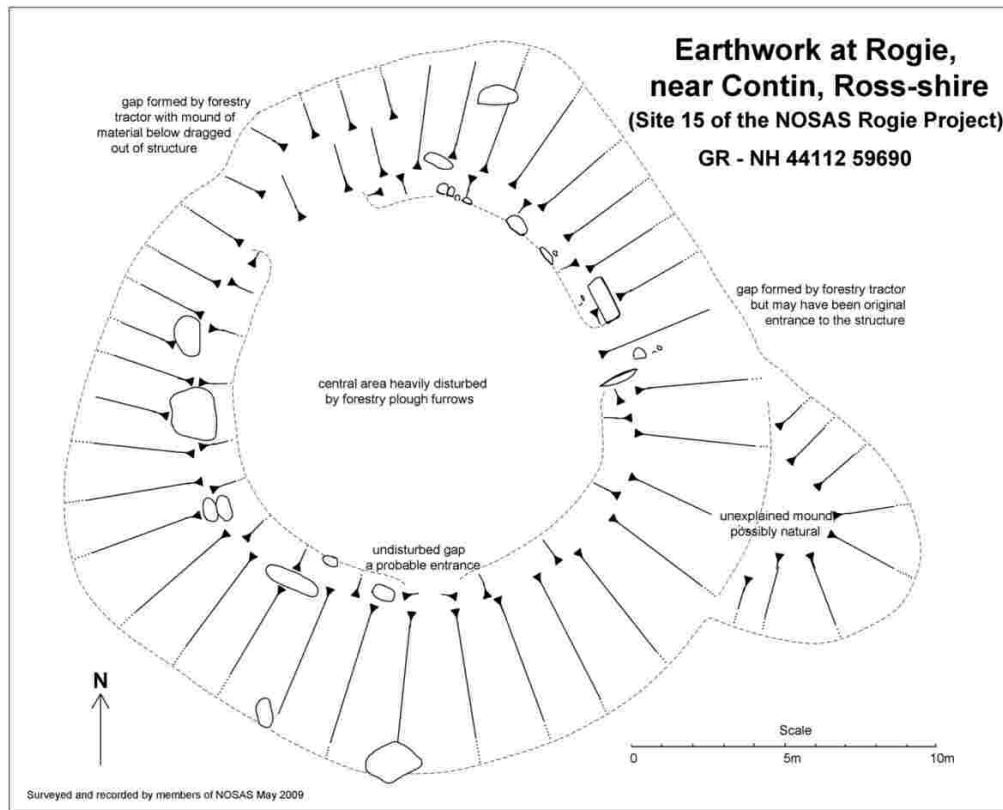
**15 Ringed earthwork/Possible Dun** - NH 44112 59690 A raised circular feature with an encircling bank which contains large stones, some of which may be in-situ boulders. The internal diameter of the feature is c12m. The bank is 1-1.5m high externally and generally 0.3-0.5m high internally. It has a spread of 2 - 3m. There is a possible entrance, c2m in width in the eastern arc but this may have been caused by heavy forest machinery. The whole site has been grossly trashed by tree planting, felling and reploughing, with furrow marks across the internal area. See plan

The massively walled circular structure No 15, see drawing on page 18, could be the remains of a dun, and that would place it in the Iron Age. No hut circles from the Bronze Age were found in the project area, but several are known on the west side of the Blackwater, opposite Rogie.

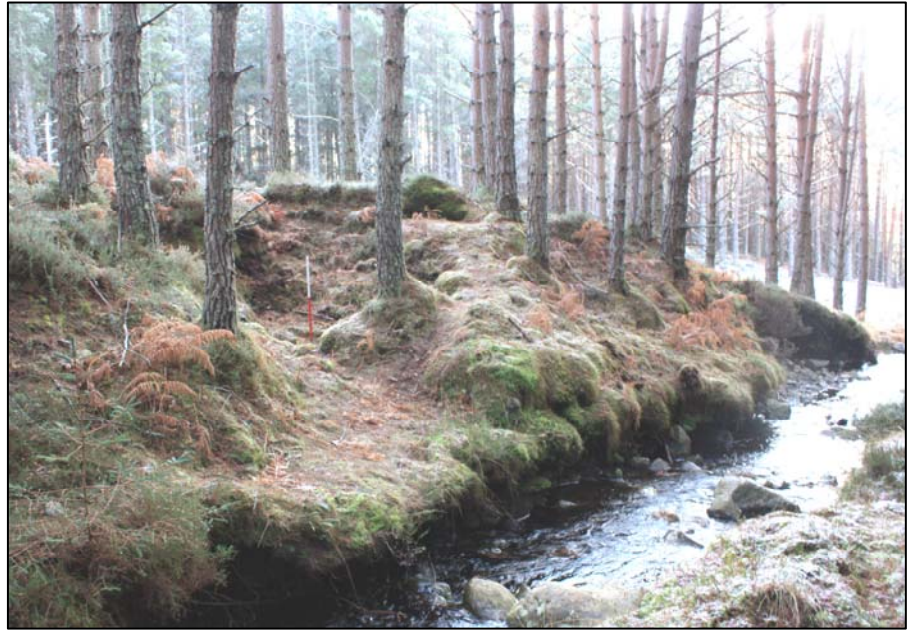
*Figure 1.* Possible still bothy, site 69 from the north

**69 Possible still bothy (figure 1)** - NH 43636 60489 Immediately to the ESE of the small burn is a hollow in the bank c.2-3m deep, 3.2m N-S and 2.3m wide. The W edge has been enclosed by a low tumbled wall c. 1.75m long and 0.5m wide; the S end is slightly curved. On the NNE edge of the hollow there is a short section of wall face which suggests there may have been a revetted wall, it is difficult to trace further around the bank. To the W this revetted wall has tumbled into a gap between the bank and the surviving enclosing wall.

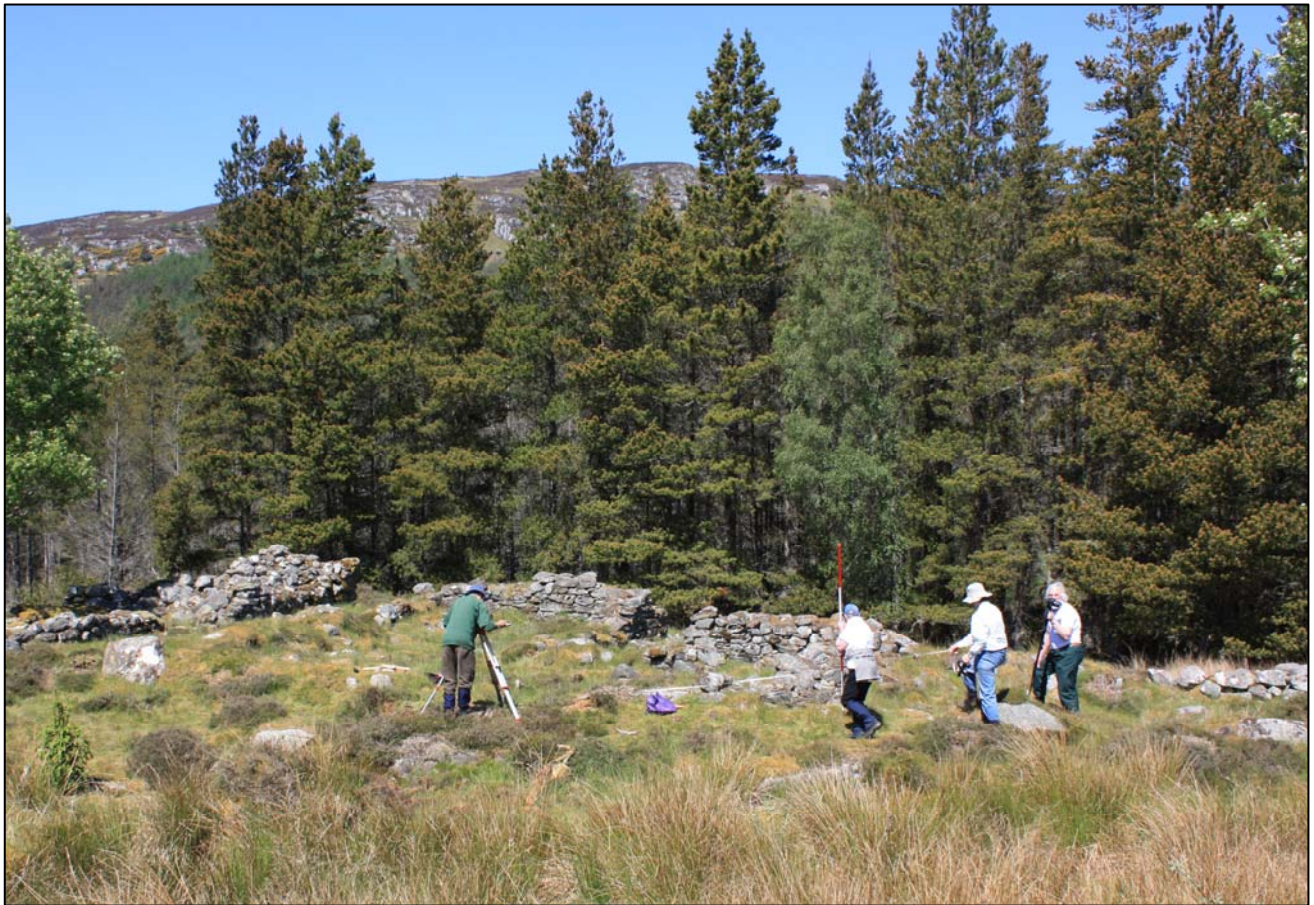
*Figure 4. NOSAS team in action, planetabling buildings 61 and 62 at NW settlement*

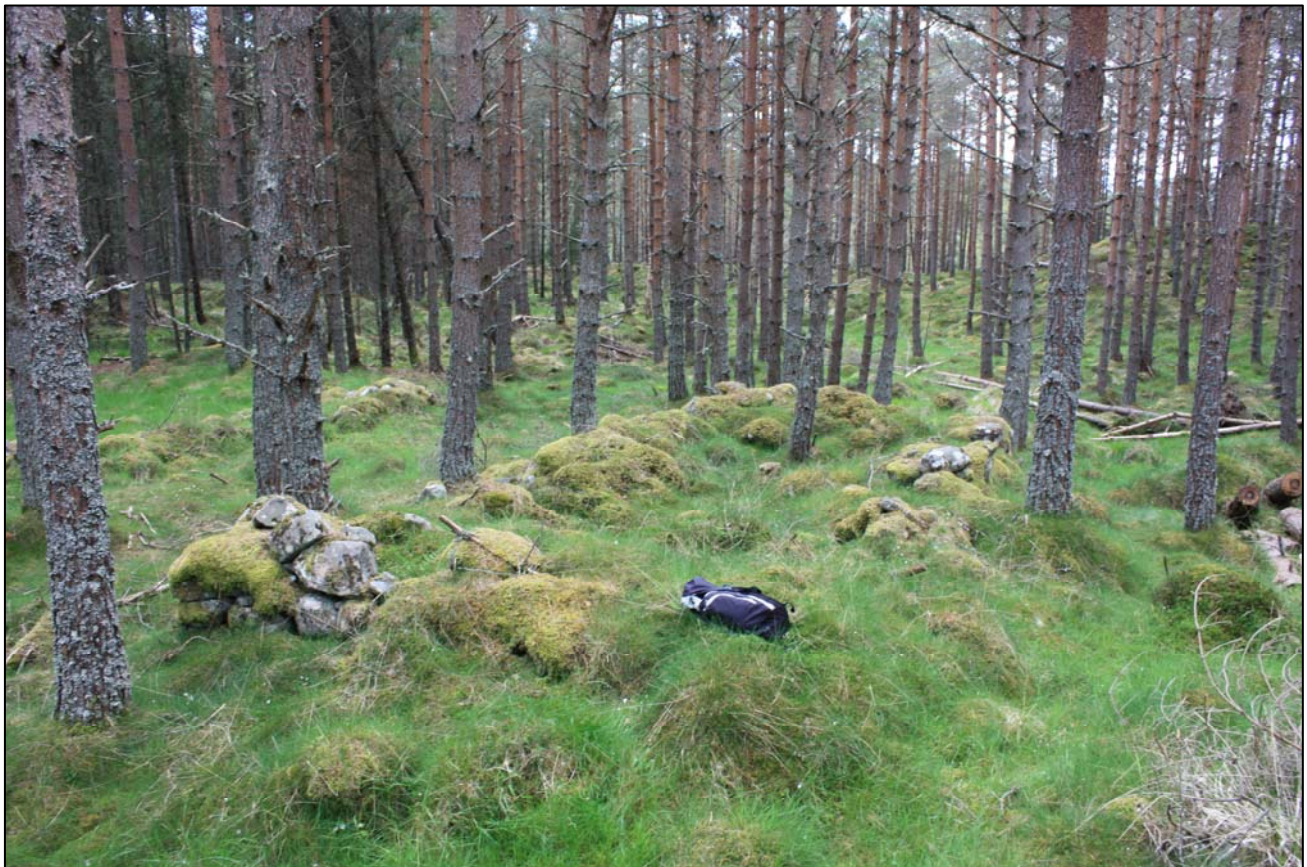
*Figure 5. Moss covered footings of Building 59 in the trees*

**59 Building** (*figure 5*) - NH 43731 60050 A rectangular structure on a NE-SW alignment measures c7.5m x 2.5m internally. The remains of the dry stone walls are generally 0.5-0.6m high and have a spread of 0.8m. There is a considerable amount of tumble in the NE end of the building and an entrance, 0.7m wide in the SE wall. The building is grass and moss covered and has been planted with trees

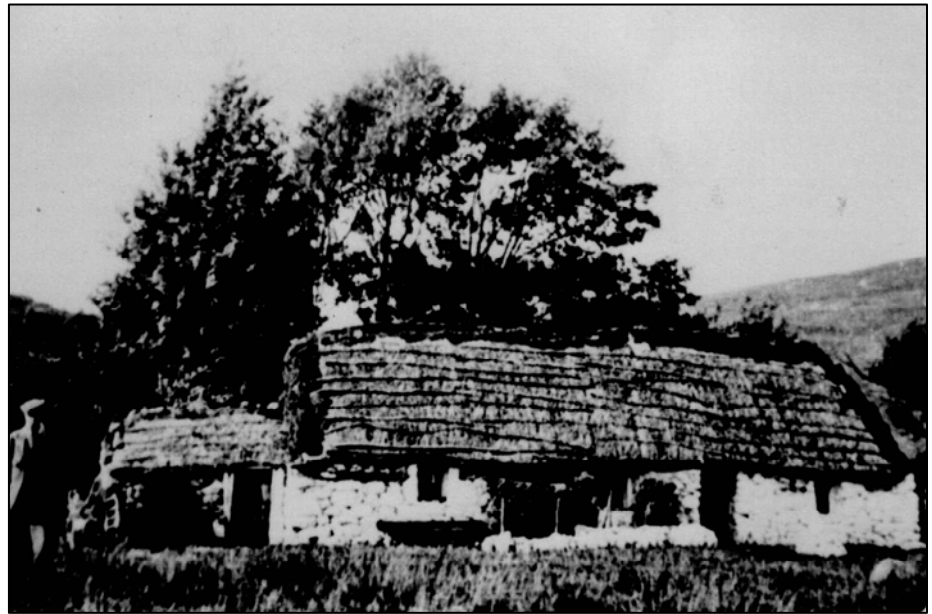
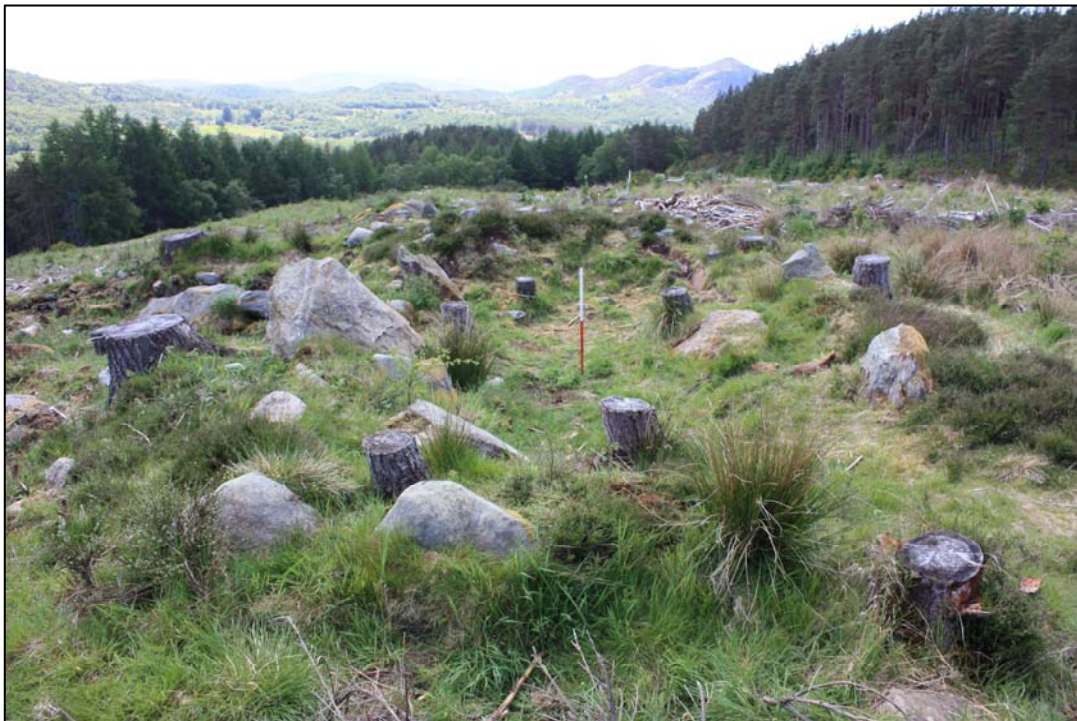
*Figure 6.* Site 35, Macqueens croft as it is today, 2008 and *Figure 7.* below as it was c1920 with James MacQueen himself beside it. (Unable to trace source of photo)

**35 Building (alternative name - MacQueens croft)** (figures 6 and 7) - NH 44165 60069

The main building of this settlement. It is the westmost of 2 with an enclosure, 37, to the rear. The building has 2 compartments and an outshot to the SW. It has an internal measurement of 11m x 3.5m, with the main compartment to the west being 6m in length. The tumbled dividing wall is 0.5m high and has a spread of 1m. The walls are of dry stone construction, double faced and 0.7m in thickness. The rear wall is generally 1m in height and turfed up on the outside.

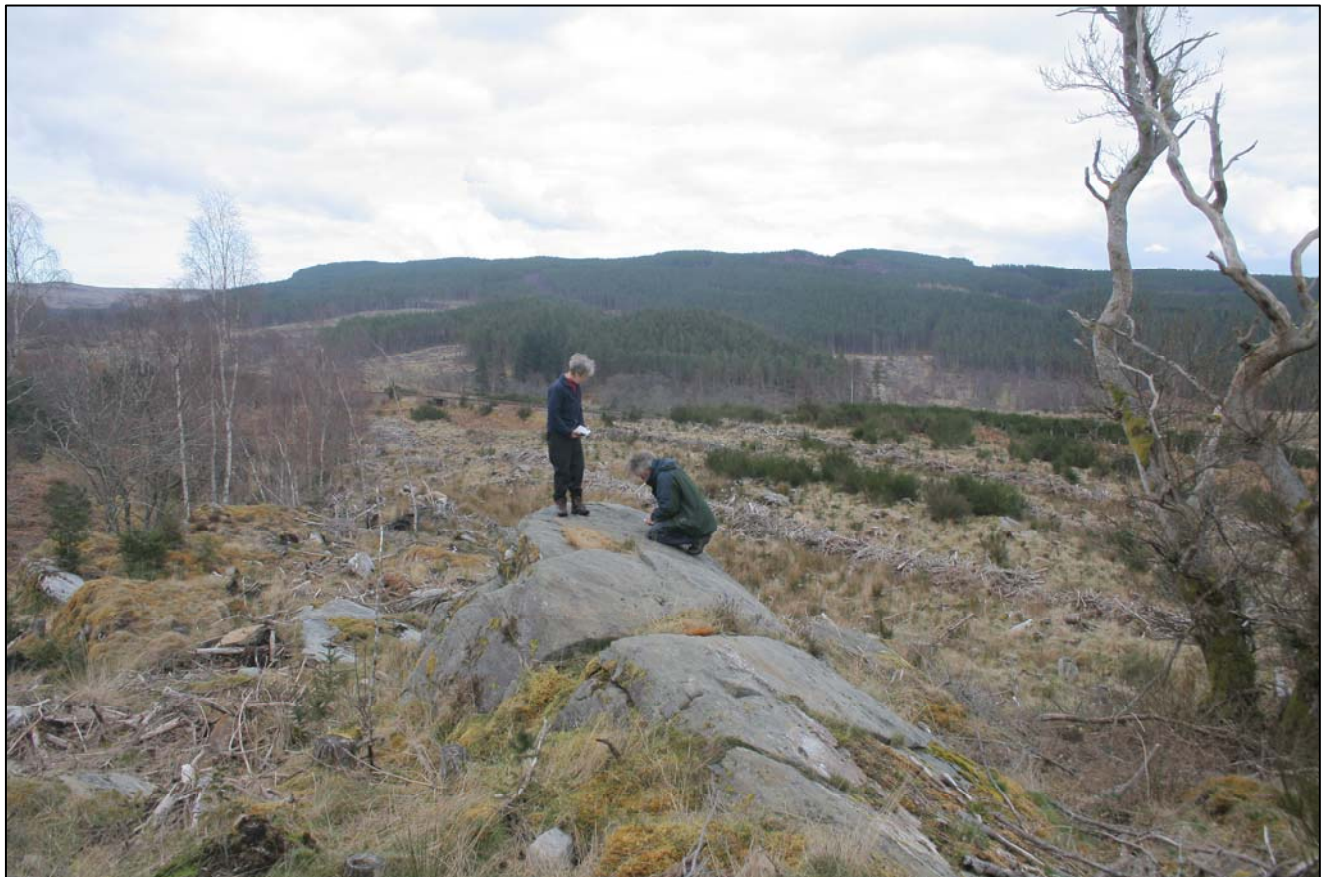
*Figure 9. Cup marked outcrop 18*

**18 Cup marked outcrop** (figure 9) – NH 43960 59808 A linear outcrop of rock on the SE side of the summit of a prominent knoll has 22 cups on it. Most of the cups are along the upper edge and are quite worn.
